Manhole Inspection Summary

Manhole # S33YY1014MH

Location Address: **5303 PURLINGTON WAY**

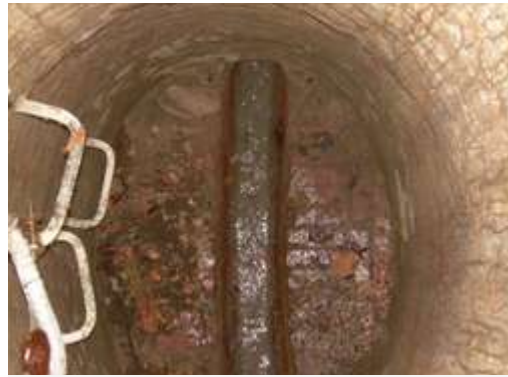
Top View

☐ Parged ☒ **Debris** (not Condition related)

Surcharge ☒ **Evidence Of Surcharge** Depth: **1** (ft.) ☐ Active Surcharge Present

Evidence of surcharge - Bench debris.

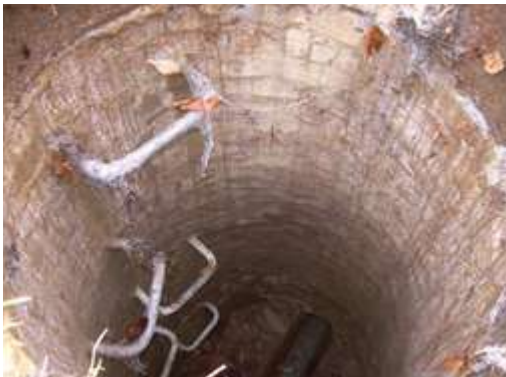
Defect

Frame leaks. Adjustment deterioration and infiltration - other side.

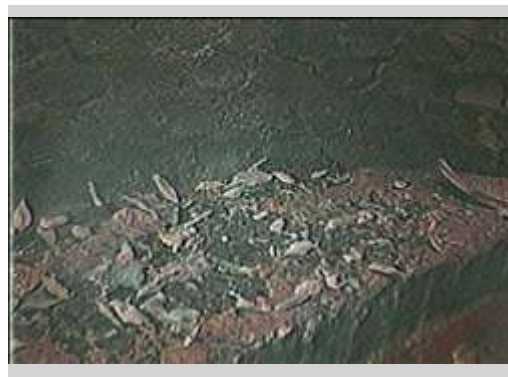
Defect

Condition: ☐ Sound ☐ Cracked ☐ Root Intrusion ☐ Loose Brick ☒ **Deteriorated**

Infiltration: ☐ None ☐ Joint ☐ Cracks ☒ **Mortar** ☐ Roots ☒ **Wall**

Barrel deterioration and infiltration.

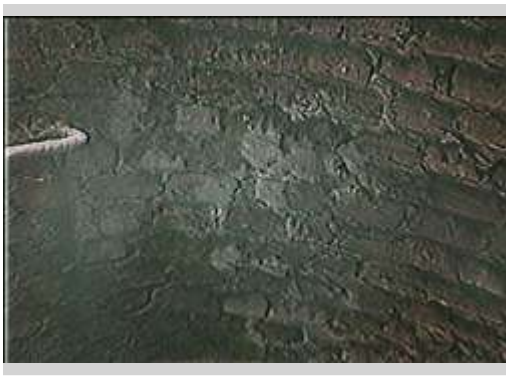
Defect

Condition: ☐ Sound ☐ Cracked ☐ Root Intrusion ☐ Loose Brick ☒ **Deteriorated**

Infiltration: ☐ None ☐ Joint ☐ Cracks ☒ **Mortar** ☐ Roots ☒ **Wall**

Corbel and Barrel deterioration and infiltration.

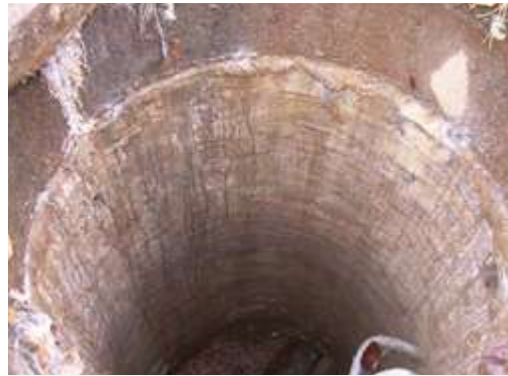
Defect

☒ **Leaks**

Condition: ☐ Sound ☐ Cracked ☐ Root Intrusion ☐ Loose Brick ☒ **Deteriorated**

Infiltration: ☐ None ☒ **Joint** ☐ Cracks ☐ Mortar ☐ Roots ☒ **Wall**

Frame leaks. Adjustment deterioration and infiltration.

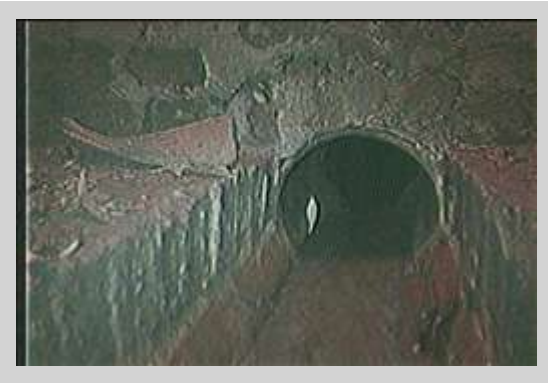
8 in. Circular Gravity Sewer Pipe Out @ 12 O'Clock

Channel deterioration.

Infiltration: **Evidence** Pipe Seal Cond: **Unknown**

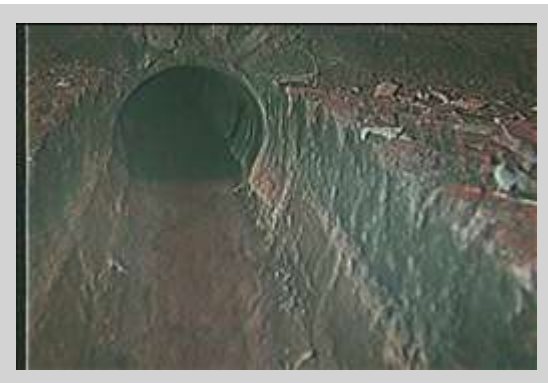
8 in. Circular Gravity Sewer Pipe In @ 5 O'Clock

Infiltration: **Evidence** Pipe Seal Cond: **Unknown**
